Effects of gelcoat thickness on mechanical properties of woven glass/polyester laminated composite

ABSTRACT

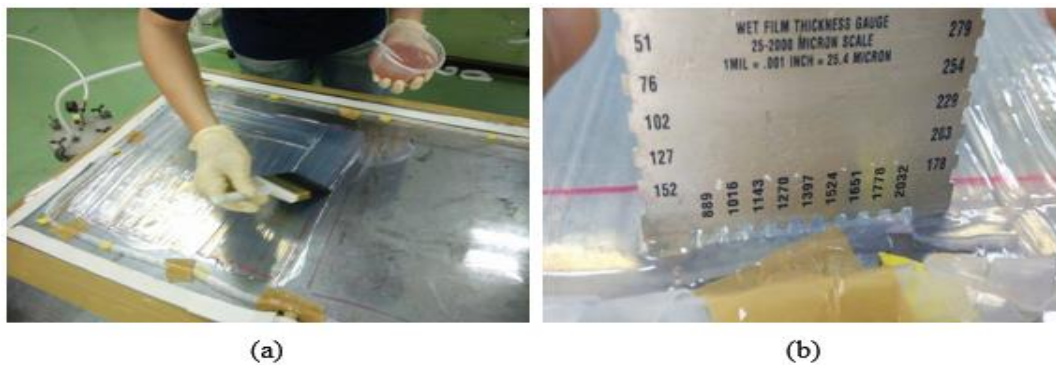
Figure 1. (a) Gelcoat application using brush, and (b) thickness measurement.

Gelcoat layers were applied on the glass/polyester composites by using hand lay-up method as illustrated in Figure 1(a). The gelcoat was applied using brush on the surface of plastic film after cleaning process to prevent any contamination. Each coated layer was measured by using wet film thickness gauge as shown in Figure 1(b), to ensure the gelcoat was spread evenly on the surface and left for 10 minutes to cure. The steps were repeated until the desired gelcoat thickness was acquired. In order to prevent the external force or pressure from being applied to the gelcoat layer, each ply of glass fiber was wetted with resin before being placed on the gelcoat. The samples were then wrapped according to standard sequence of vacuum bagging technique using peel ply, perforated film, breather, mesh flow and lastly covered by bagging plastic. The laminated composites were left for 24 hours to let them cure completely.

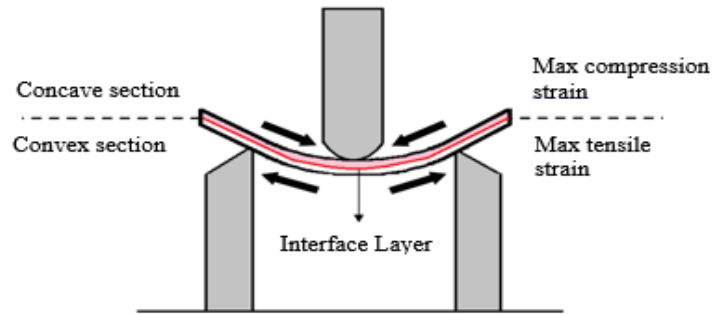
Figure 2. Concave and convex face under three point flexural test.

Tensile test was conducted in accordance to ASTM D3039-00 standards. The specimens were analysed at a speed rate of 2 mm per minute. The stress strain gauge curve resolved the interfacial bonding strength of various gelcoat thickness. Figure 2 showed the same machine (Shimadzu Universal Testing Machine) as agreeing in ASTM D790-02 was used to perform the flexural test in two ways, i.e., coated surface facing the load (concave) and bare surface facing the load (convex) to measure the samples. The objective was to record the failure behaviour of gelcoat on both concave and convex face. Each gelcoat thickness was tested with 8 samples and the average value was listed. The maximum compressive strain value of stress was found at concave side while maximum tensile value was found at convex side. Six different thickness of gelcoat

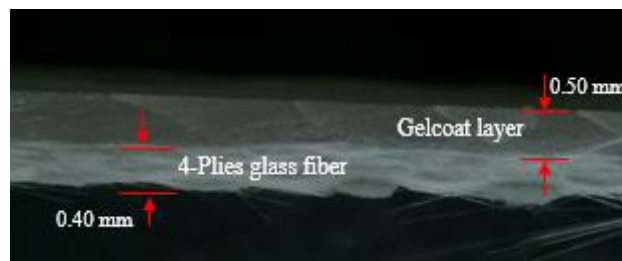
Figure 3. A cross-sectional image of the coated composite.

were used in total, i.e., 0.25, 0.30, 0.35, 0.4, 0.45 and 0.50 mm. Figure 3 showed the cross-sectional image of the coated laminated composite.

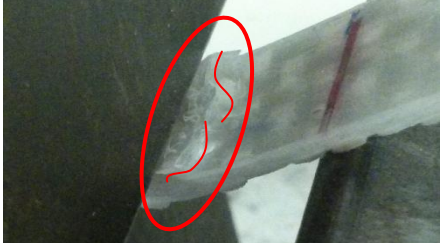
<p>Thickness = 0.25mm</p>

<ul style="list-style-type: none"> • Crack Pattern: Crack starts from the direct contact point between the crosshead bar and gelcoat surface. • Scenario: Some of the gelcoat fragments are detached from the specimen during the test. Obvious gelcoat cracking can be observed.
<p>Thickness = 0.30mm</p>

Table 2 shows the deflection and failure behavior of glass/polyester composite coated with different thickness of gelcoat under flexural loading with the gelcoat side is concavely bent. The gelcoat thickness of 0.25 mm that was concavely bent showed the gelcoat fractured at the compression point between the crosshead and the specimen. However, the fractured pieces did not stick to the laminates but drop off from the specimen. When the gelcoat thickness is increased to 0.30 mm, a different crack pattern is observed. The crack is observed at a position few millimeters from crosshead bar, instead of directly below it. This is probably due to the specimen not transferring the load applied equally along the surface of gelcoat and the specimen started to crack at the defect of the gelcoat which located at the edge of specimen [10]. The specimen shows flexibility to recover back but not exactly to its original shape with little bent condition. Composites coated with gelcoat thickness of 0.35 mm and 0.40 mm show a similar cracking behavior which exhibit smooth gelcoat surface but contain few internal cracks. Most of the internal cracks occur directly parallel to the crosshead bar but do not reach the surface of the gelcoat.

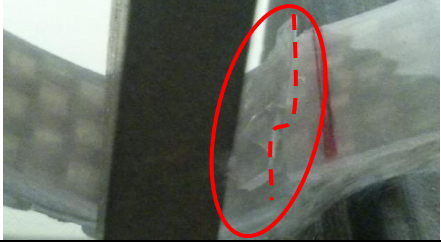
<ul style="list-style-type: none"> • Crack Pattern: Gelcoat crack occurs not directly under crossbar but few millimeters from it. • Scenario: The gelcoat cracks stick along with the laminates.
<p>Thickness = 0.35mm</p>

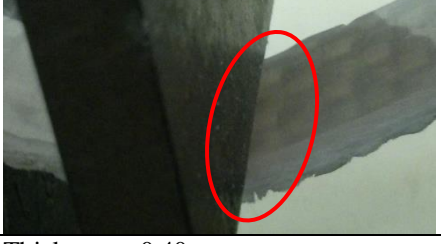
<ul style="list-style-type: none"> • Crack Pattern: Few internal cracks that propagate horizontally across the specimen are observed in the gelcoat. • Scenario: The gelcoat surface is smooth and without any obvious surface crack.
<p>Thickness = 0.40mm</p>

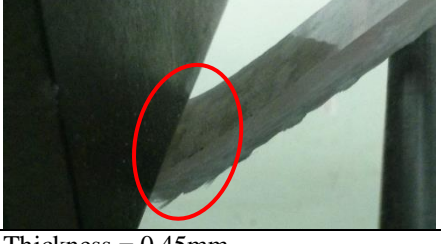
<ul style="list-style-type: none"> • Crack Pattern: Few internal cracks that propagate horizontally across the specimen are observed in the gelcoat. • Scenario: The gelcoat surface is smooth and without any obvious surface crack.

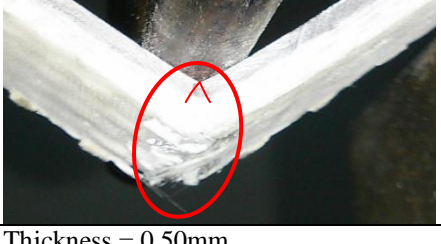
<p>Thickness = 0.45mm</p>

<ul style="list-style-type: none"> • Crack pattern: The gelcoat surface is smooth but serious internal crack and spacing appears at the middle of specimen. • Scenario: The specimen is unable to recover back to its original shape.
<p>Thickness = 0.50mm</p>

However, when the gelcoat thickness is increased to 0.45 mm and 0.50 mm, cracks are spotted at the edge of the specimen where the interface between the gelcoat and laminates is located. The gelcoat surface for 0.45 mm maintains as clean and smooth surface but not in the 0.50 mm, where obvious surface cracks are observed. As in concave bending, the gelcoat surface faces the maximum compression load but the middle of the specimen acts a neutral axis. Since the laminates of different gelcoat are the same, the maximum tensile value sustain by the laminates are the same after the gelcoat is completely fail.

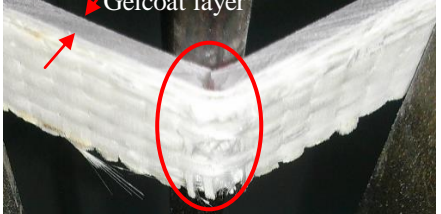
<ul style="list-style-type: none"> • Crack pattern: Obvious gelcoat surface cracks with spacing in between and direct link to internal cracks are observed. • Scenario: Some tiny cracks occur at the edge of the specimen but do not propagate across the specimen.

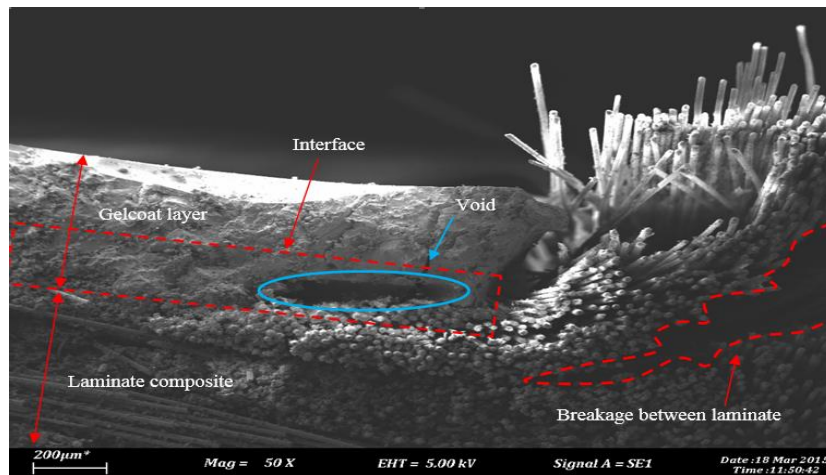
Figure 4. Failure found in the sample with 0.25 mm gelcoat thickness.

Failure analysis is very important in the design procedure to assure the material properties by combining tests [12]. In order to determine the failure pattern of the samples, one sample was selected from the highest and lowest thickness to be analyzed using scanning electron microscope (SEM). The purpose is to elucidate the crack pattern at the failure point. As shown in the SEM image in Figure 4, there is an obvious breakage between the laminates that caused by the compression of the crosshead bar in the composite coated with 0.25 mm thick gelcoat. This indicates the interface bonding between gelcoat and laminate is well bonded in 0.25 mm that although the laminate has failed but the interface bonding is still maintained. Defect like voids are also observed to appear between the gelcoat and laminate that may cause the weakening of the mechanical strength. Knoeller and Rome [13] stated that a reduction of nearly 7 % for every 1 % of voids present was experienced by the interlaminar strength, up to a void content of 4 %. Moreover, for each 1 % incline in voids, the fatigue life of fiber-reinforced polymer matrix composites was weakened by 5 % and the strength by approximately 5 %. This degradation in strength properties lead polymer matrix composites to be more exposed to reduction in aggressive environments.

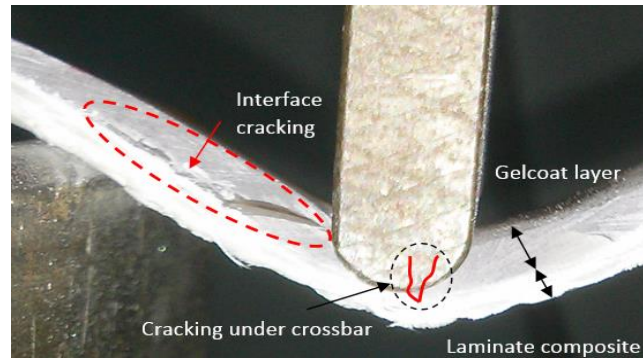
Figure 5. Fracture occur at sample of 0.50 mm gelcoat thickness.

The image of 0.5 mm gelcoat thickness sample under flexural loading is shown in Figure 5. It is certainly discovered that a crack occurs in the middle of the compression point and generates an obvious surface crack and spread till the interface until the total fracture take place. The appearance of slight voids close to the interface between the gelcoat and laminates is shown in the cross-section of the sample with 0.50 mm gelcoat thickness in Figure 6. This explained the interface cracking in Figure 4. The mechanical strength is declined because the cracking spread through the tiny void and unable to bear the compression load.

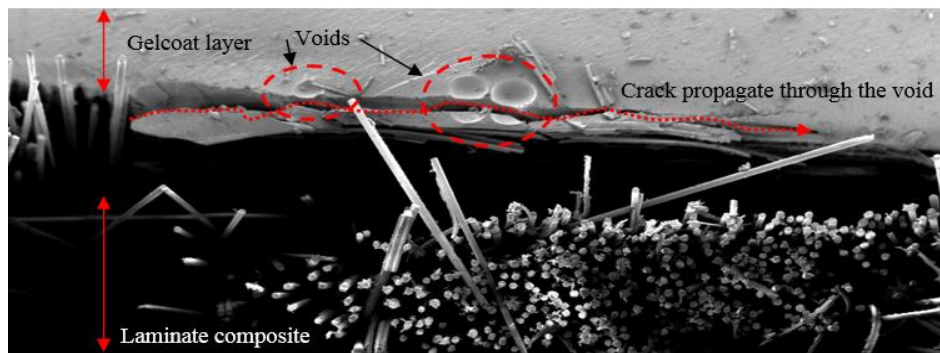
Figure 6. Tiny voids found at the interface between gelcoat layer and laminates.

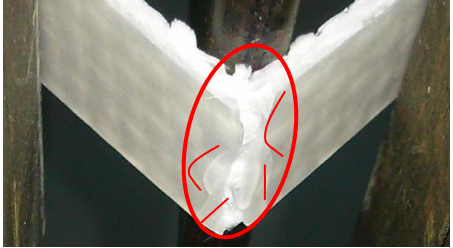
<p>Thickness= 0.25mm</p>

<ul style="list-style-type: none"> • Crack Pattern: Many tiny cracks are observed around the failure edge. • Scenario: Horizontal crack occurs at the gelcoat surface directly under the crosshead bar.
<p>Thickness= 0.30mm</p>

Table 3 shows the deflection and failure behavior of glass/polyester composite coated with different thickness of gelcoat under flexural loading with the gelcoat side is convexly bent. Composite coated with 0.25 mm of gelcoat thickness that was bent convexly showed a break directly under the compression point. The failure pattern of the gelcoat is a clean breakage which is straight and different to the gelcoat bent concavely that shows multiple cracks on the break point. There are few tiny cracks appear on the crack point of the gelcoat which combine as they propagate. In the composite coated with 0.30 mm gelcoat, the crack begins next to the compression point. For the gelcoat thickness of 0.35 mm and 0.40 mm, they experience the same failure condition with cracks start at the middle point of the specimen and propagate till opposite edge side with branch cracking pattern. Although there are small tiny crack occur at the edge in the same time, but once a crack have linking with the internal crack propagation, the crack turns into failure in a second.

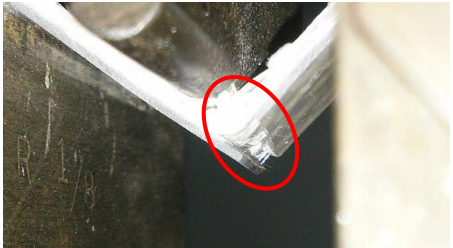
<ul style="list-style-type: none"> • Crack Pattern: A clean horizontal crack along the sample. • Scenario: Gelcoat crack occurs not directly under the crosshead bar but few millimeters next to the crack point.
<p>Thickness= 0.35mm</p>

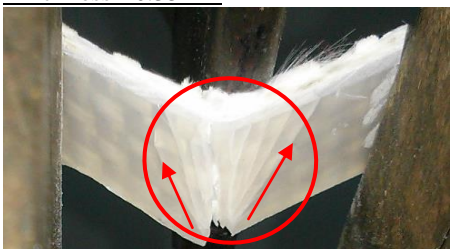
<ul style="list-style-type: none"> • Crack Pattern: Branched crack starting at one point and spread across the specimen. • Scenario: The gelcoat crack starts at the edge of the specimen and propagates throughout the specimen.
<p>Thickness= 0.40mm</p>

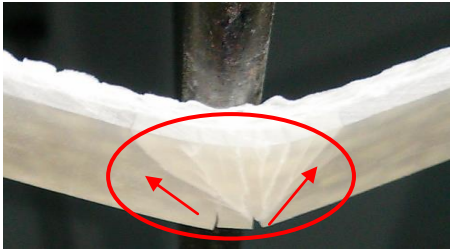
<ul style="list-style-type: none"> • Crack Pattern: Two edge cracks occur but only one crack propagates and forms a branched crack. • Scenario: There are more than one gelcoat crack started at the edge of the specimen but only one point propagates separately through the specimen while the other stops propagating.

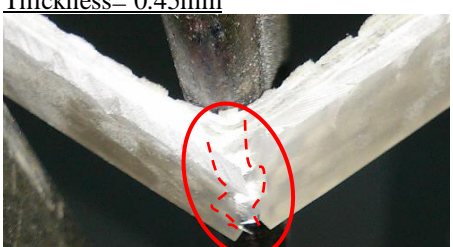
<p>Thickness= 0.45mm</p>

<ul style="list-style-type: none"> • Crack Pattern: Inconsistent teeth crack pattern is observed at the crack edge. • Scenario: A fast gelcoat failure occurs and causes direct drop of the maximum stress value. The crack edge shows inconsistent teeth structure.
<p>Thickness= 0.50mm</p>

Composites coated with 0.45 mm and 0.50 mm gelcoat show different crack propagation pattern under convex bending. The gelcoat thickness of 0.45 mm shows the teeth pattern crack propagation, while 0.50 mm gelcoat shows a crack pattern that starts from many tiny cracking that propagate to one single point. The gelcoat crack point continues to expand along the crosshead compression point continuously. The glass fiber break is not that obvious in the convex bending compares to the concaves bending. Baghaei et al. [14] stated that failure will occur when the weakest fiber hit its limiting tensile stress because of all the fibers in the composite under the same stress since identical specimen is subjected to tensile forces.

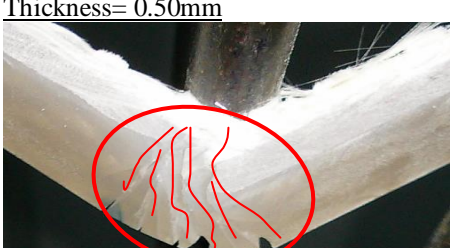
<ul style="list-style-type: none"> • Crack Pattern: Less branched crack occurs but higher spacing observed between the cracks formed. • Scenario: A sudden fracture occurs and propagates across the specimen. The crack point expanding directly under the crosshead bar while other crack next to it remains unchanged.

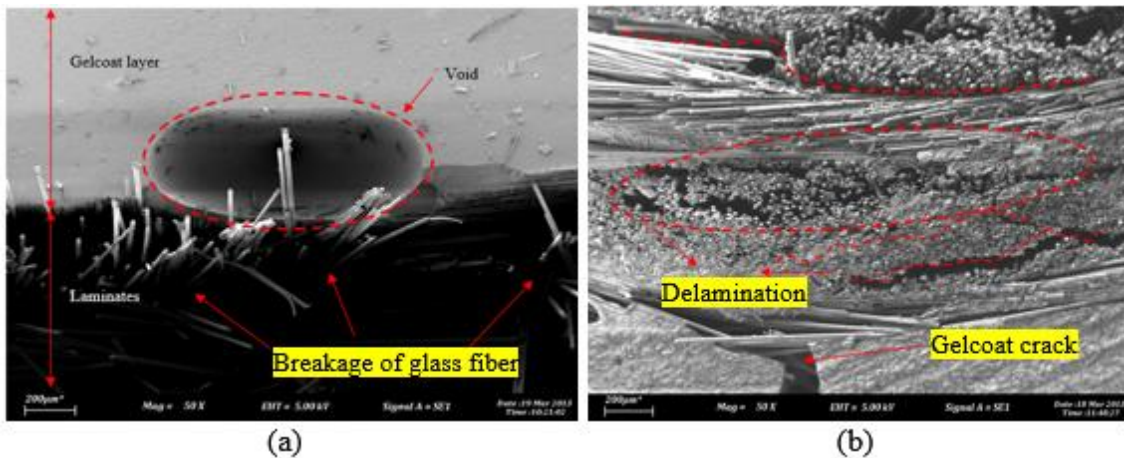
Figure 8. (a) Void discovered at the interface between gelcoat and laminates; (b) Delamination observed at the 4-ply laminate.

The purpose of the matrix in a fiber reinforced composite is to move the load to the stiff fibers through shear stresses at the interface [18]. A proper bond between the polymeric matrix and the fibers is required in this process. The composite life span is at risk to be reduced due to the poor adhesion at the interface that cause the capabilities of the composite unable to be fully exploited and leave it defenceless to environmental attacks. From the fractured surface of flexural test samples, the SEM analysis on the cross-section showed that the failures of specimens were mostly characterized by crack propagation of gelcoat surface till the internal layer of the laminates but not through the interface. Although the higher gelcoat thickness showed failure at the interface, it was the due to voids present in the interface section that caused the weakening of mechanical strength as the gelcoat surface crack propagates till the internal layer and passed through the void as shown in Figure 8(a). Figure 8(b) shows the failure of the matrix at the four plies laminates. There are delamination in the matrix that link together and cause the debonding of the in between the fiber layers. It can define that interface bonding in between the gelcoat layer and laminates are well mechanical bonded either on the low and high gelcoat thickness. The SEM images show that the delamination usually occurs at between plies as compared to the interface.

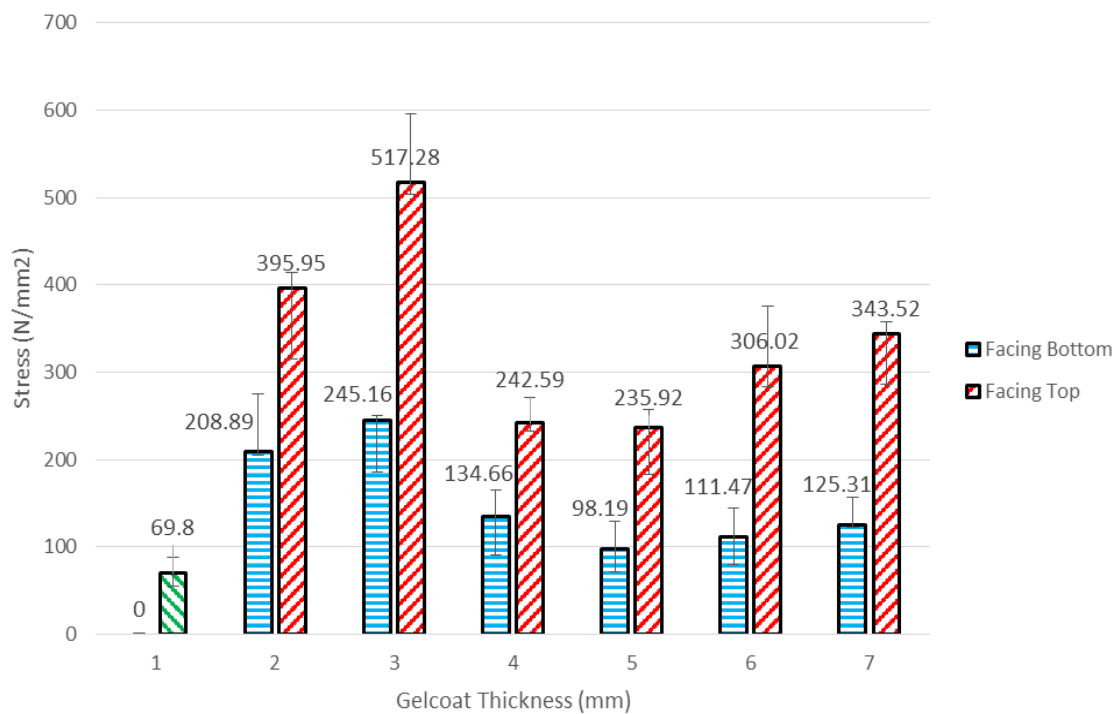
Figure 9. Flexural strength of glass/polyester composite convexly (left bars) and concavely (right bars).

However, the percentage of increase in flexural strength slightly reduces when the thickness is further increased to 0.35 mm. Moreover, sample with gelcoat thickness of 0.40 mm showed the lowest value among the coated sample at 98.19 and 235.92 N/mm² for the gelcoat facing down and up, respectively. Figure 10 shows the maximum stress obtained in the flexural tests of the composites for both measurement methods. In general, higher flexural strength is achieved when the gelcoat is facing up. Flexural strength increases again when the thickness is further increase from 0.40 mm, but the increase is small and causes an increase in material cost.

As shown in Figure 9, despite having the highest thickness of gelcoat, samples with 0.5 mm of gelcoat do not give the highest strength. The optimum thickness found in this study is slightly lower than that suggested in the Crystic Polyester Handbook [20], which states that the gelcoat thickness should be in the range 0.4 mm to 0.5 mm for most applications, or 0.5 mm till 0.6 mm thick for mold tools. At a thickness below 0.4 mm, there may be incomplete cure, reinforcement print-through and an increased probability of osmosis leading to blistering. Based on the result obtained, we suggest that when the gelcoat thickness is further inclined, it is not necessarily for the mechanical properties to improve and there is a certain optimum value for gelcoat thickness. Moreover, the gelcoat surface will be brittle at greater thickness and extra cost is not equitable as stated by other research [21 – 22].

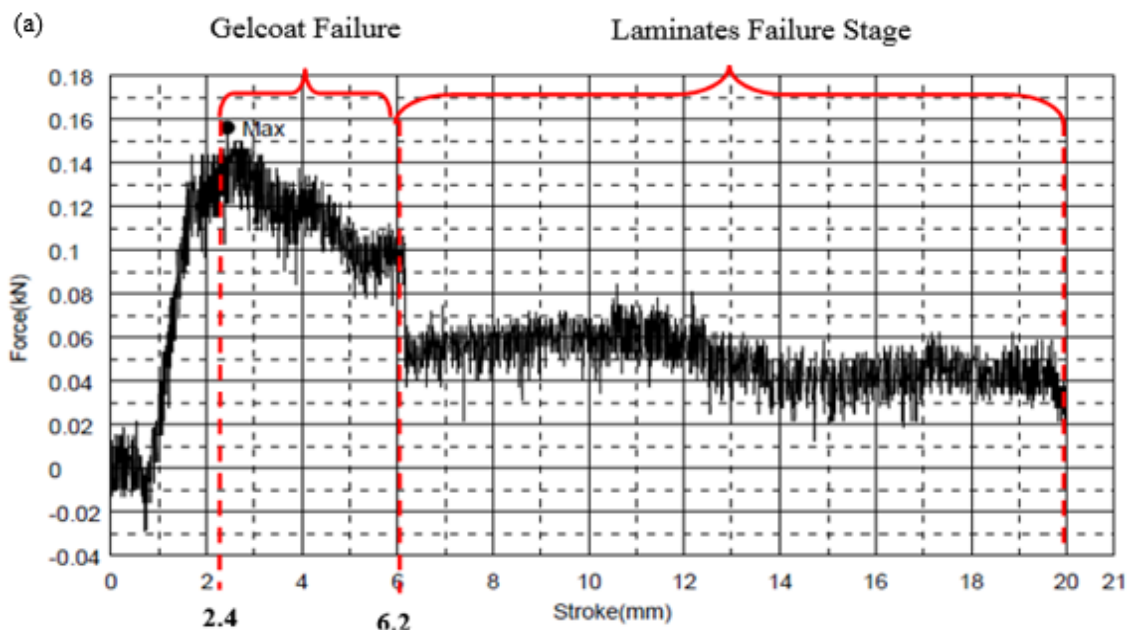
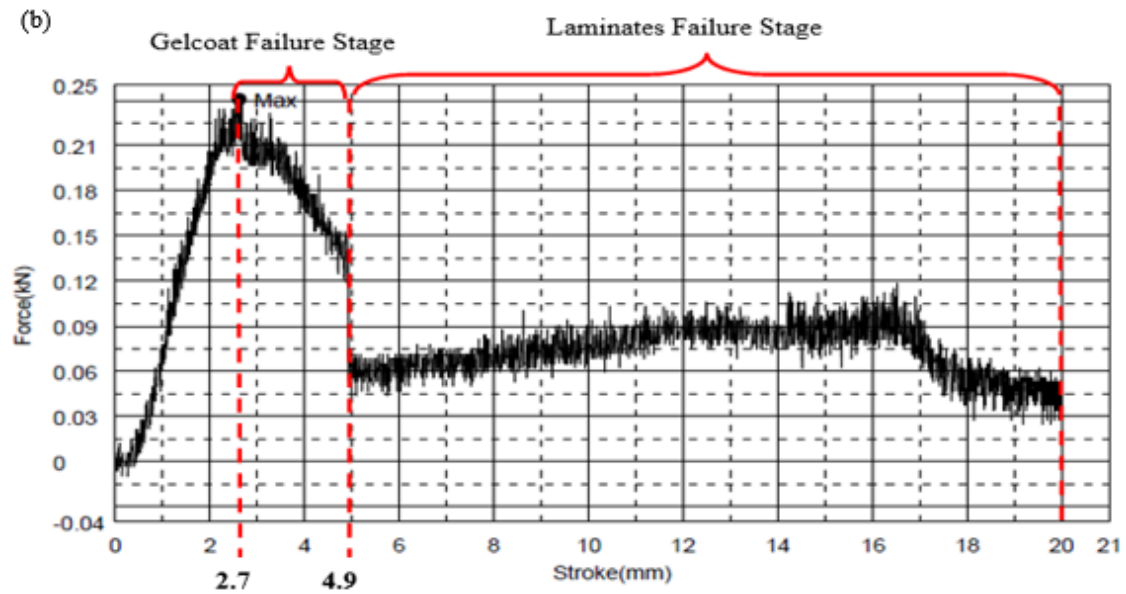
Figure 10. Graph by position of gelcoat facing (a) bottom; (b) top.

Two graphs of 0.25 mm thickness are selected to show the different steps of failure that occur in flexural test. Figure 10 (a) and Figure 10 (b) show the force-displacement curves for gelcoat bent in convex and concave, respectively. The force required for the gelcoat to fail is larger in sample with facing top (concave bending) than that facing down (convex bending). The same can be said regarding the displacement. This is because when the load transfers between plies, stress transverses to the fiber orientation also are induced in each ply before the load is finally affect the gelcoat to start cracking as suggested by Adams [23]. On the other hand, where the gelcoat is facing top position, the stress received in compressive mode. As brittle materials in general are able to sustain higher compressive stress than tensile one, this explains the larger force needed before the sample to fail when the gelcoat is bent concavely. The fracture of the gelcoat layer is more brittle and shows crack before the glass reinforced plastic as demonstrated in other study [24]. Besides, polycor is a polyester based gelcoat that becomes brittle when shock loading is applied as shown Ahmad and Izhar [25].

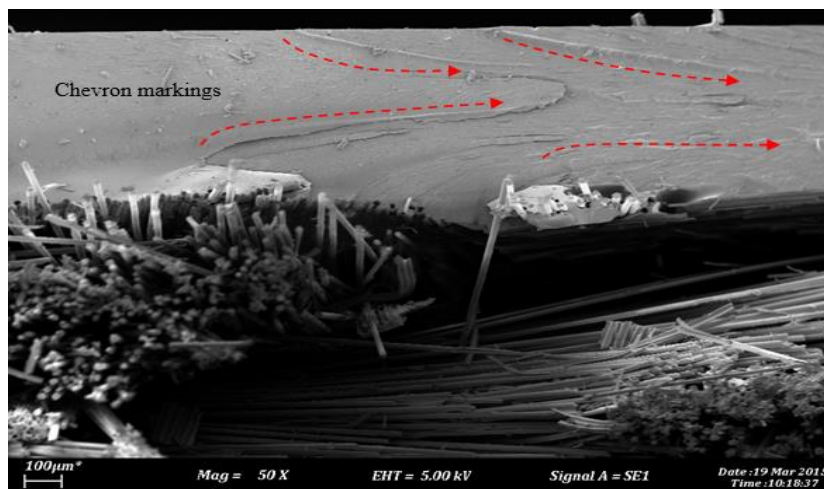
Figure 11. Chevron marking of the gelcoat layer.

As shown in Figure 11, chevron marking can be observed in the cross section of gelcoat layer. The chevron marking are facing toward the fracture point and is a good evidence to show the crack propagation region exhibits brittle fracture emanating from the crack origin. By referring to Kumara et al. [26], composites displaying good interfacial bonding characteristics exhibit brittle fracture. The presence of chevron lines is helpful in identifying the failure origin and the crack propagation directions.

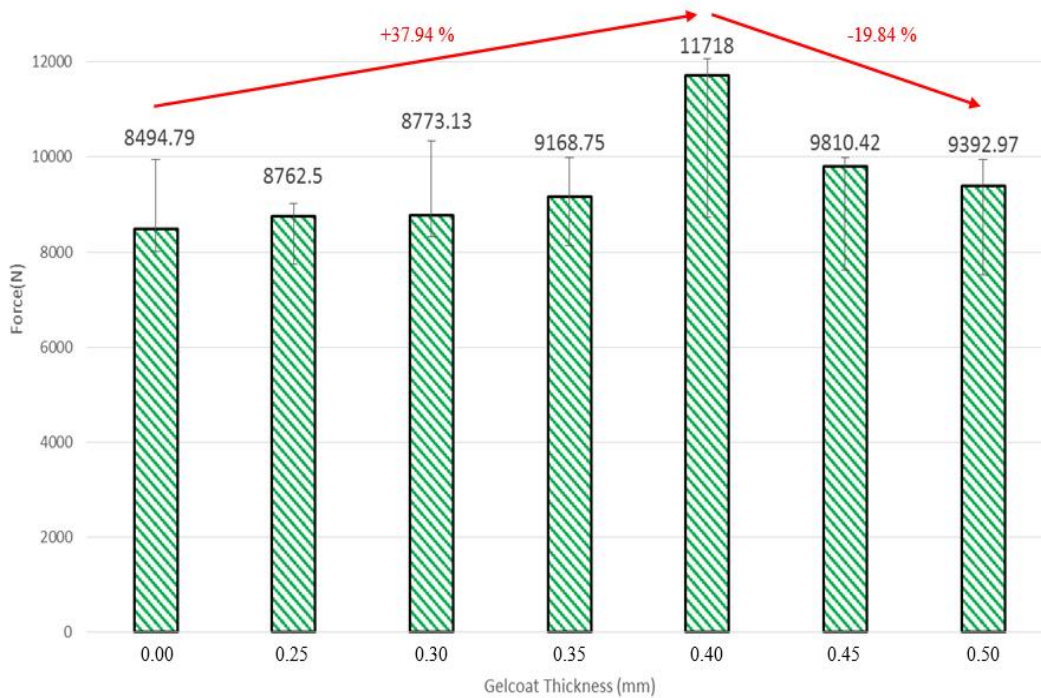
Figure 12. Graph of average maximum force sustained by glass/polyester composite coated with gelcoat of different thickness.

The average maximum force provided by glass/polyester composite coated with gelcoat of different thickness is shown in Figure 12. Meanwhile in Table 5, the percentage of incline in the maximum force before failure in the same system is shown. Based on the table, lowest tensile strength is shown by the uncoated laminated composite. When 0.25 mm thick gelcoat is applied, the tensile strength value is inclined by 3.15 %. The value is continuously inclined when 0.30, 0.35, and 0.40 mm thick gelcoat are applied significantly. When compared with uncoated composite, the composite coated with 0.4 mm thick gelcoat experienced 38 % of increase in tensile strength. However, when the thickness is increased to 0.45 and 0.5 mm, there is none dramatic increase have been recorded. The value of maximum force at failure declined almost 20% when the gelcoat thickness is increased from 0.4 mm to 0.5 mm. This happened because of increase in brittleness since the gelcoat and the resin-rich surface layer are very brittle and can consequently be ruined when overburdened [27].
